Monitoring Completed Navigation Projects (MCNP) Program

5-6 December 2005 (FY06)
Alexandria, Virginia

Coastal and Hydraulics Laboratory - ERDC

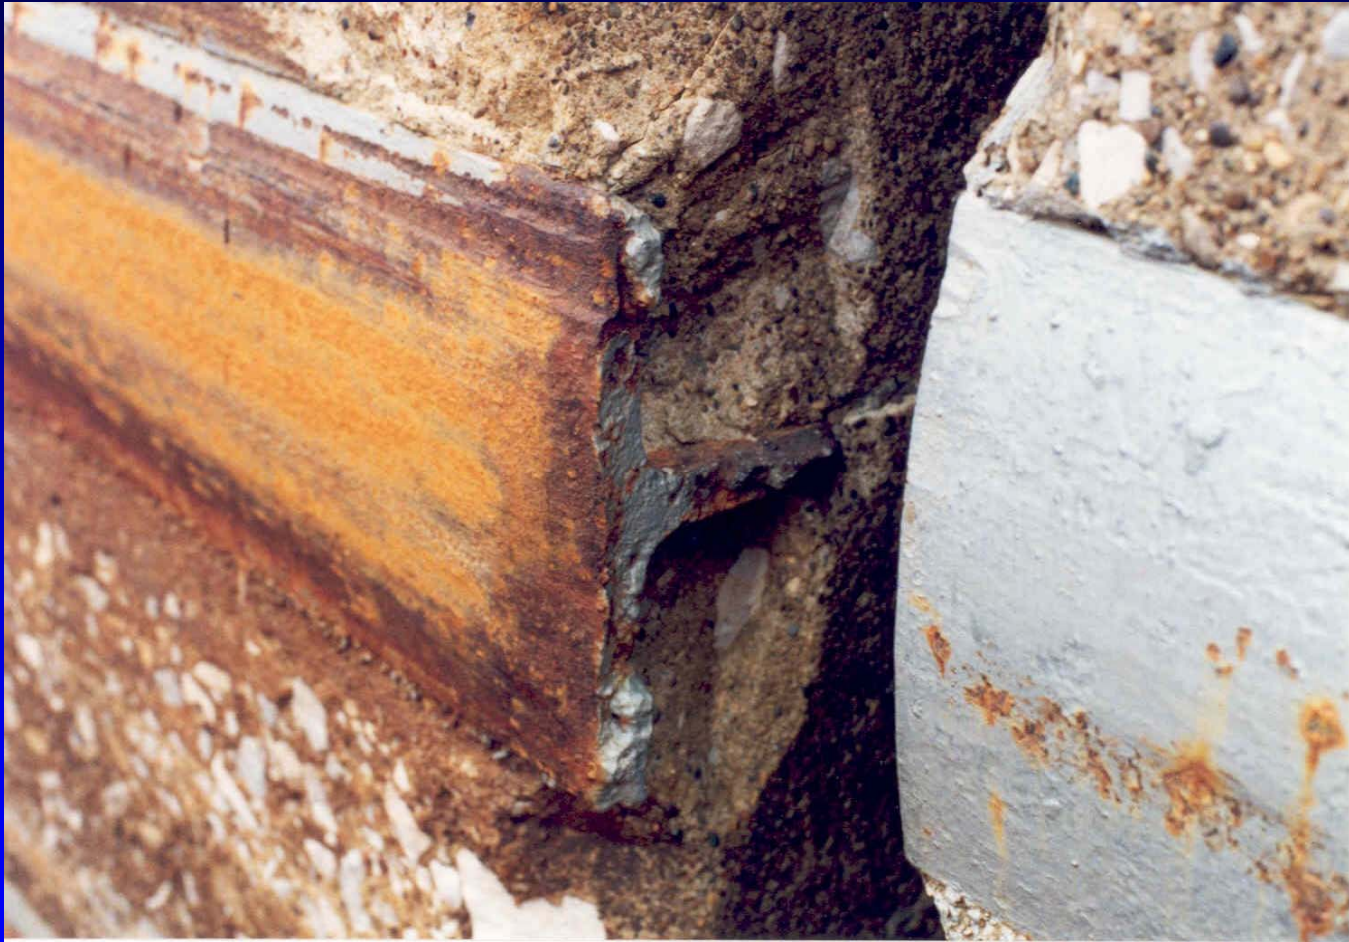
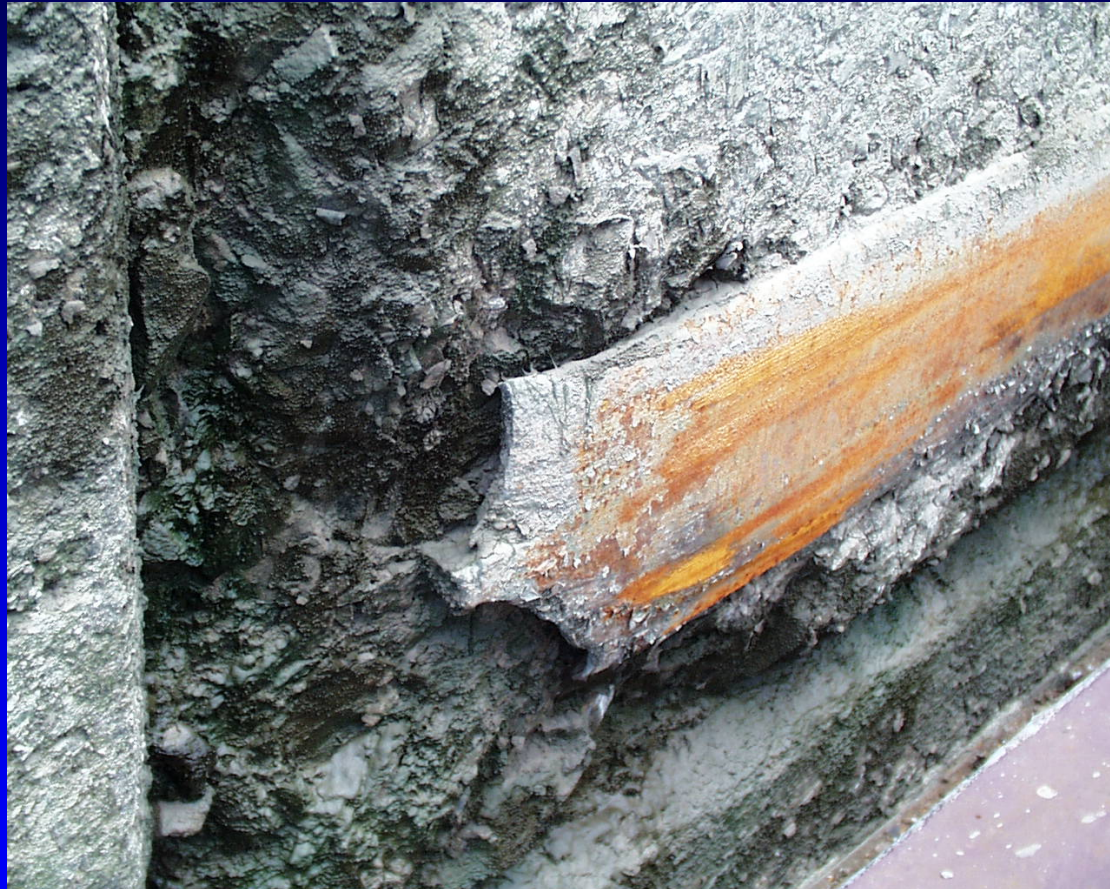
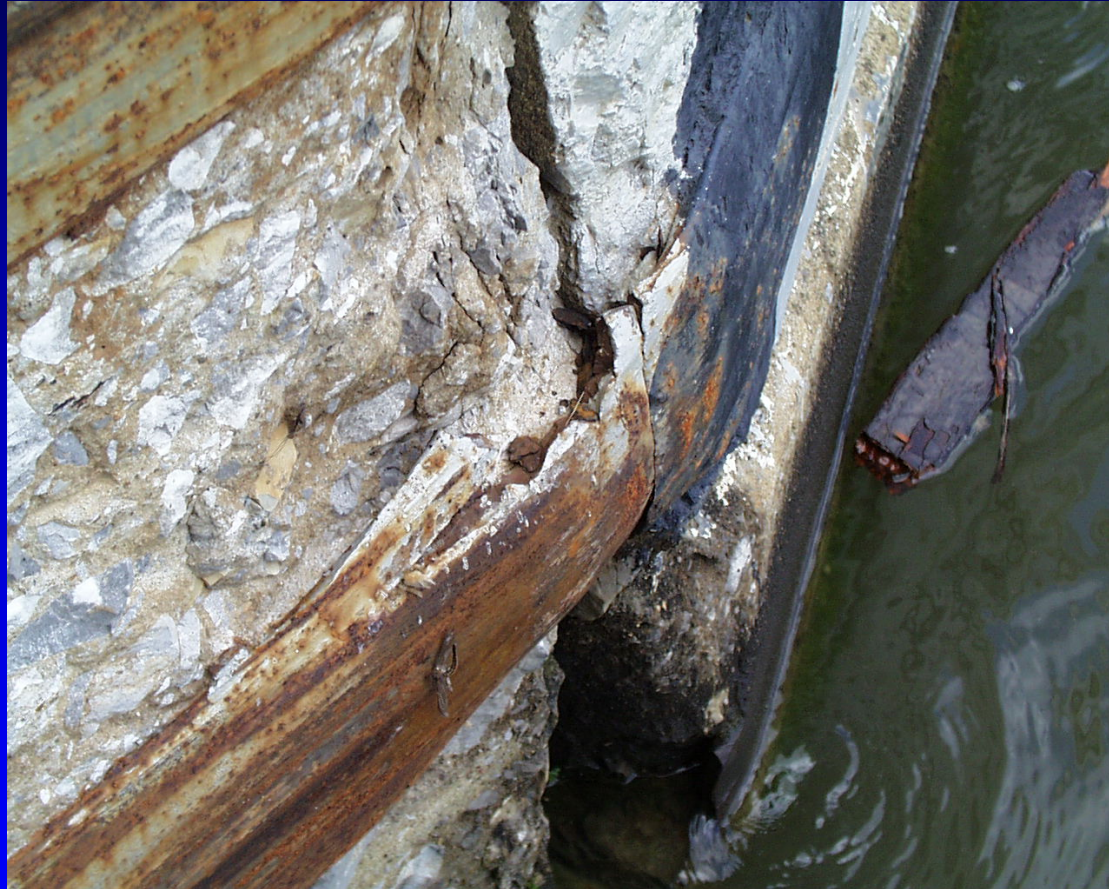
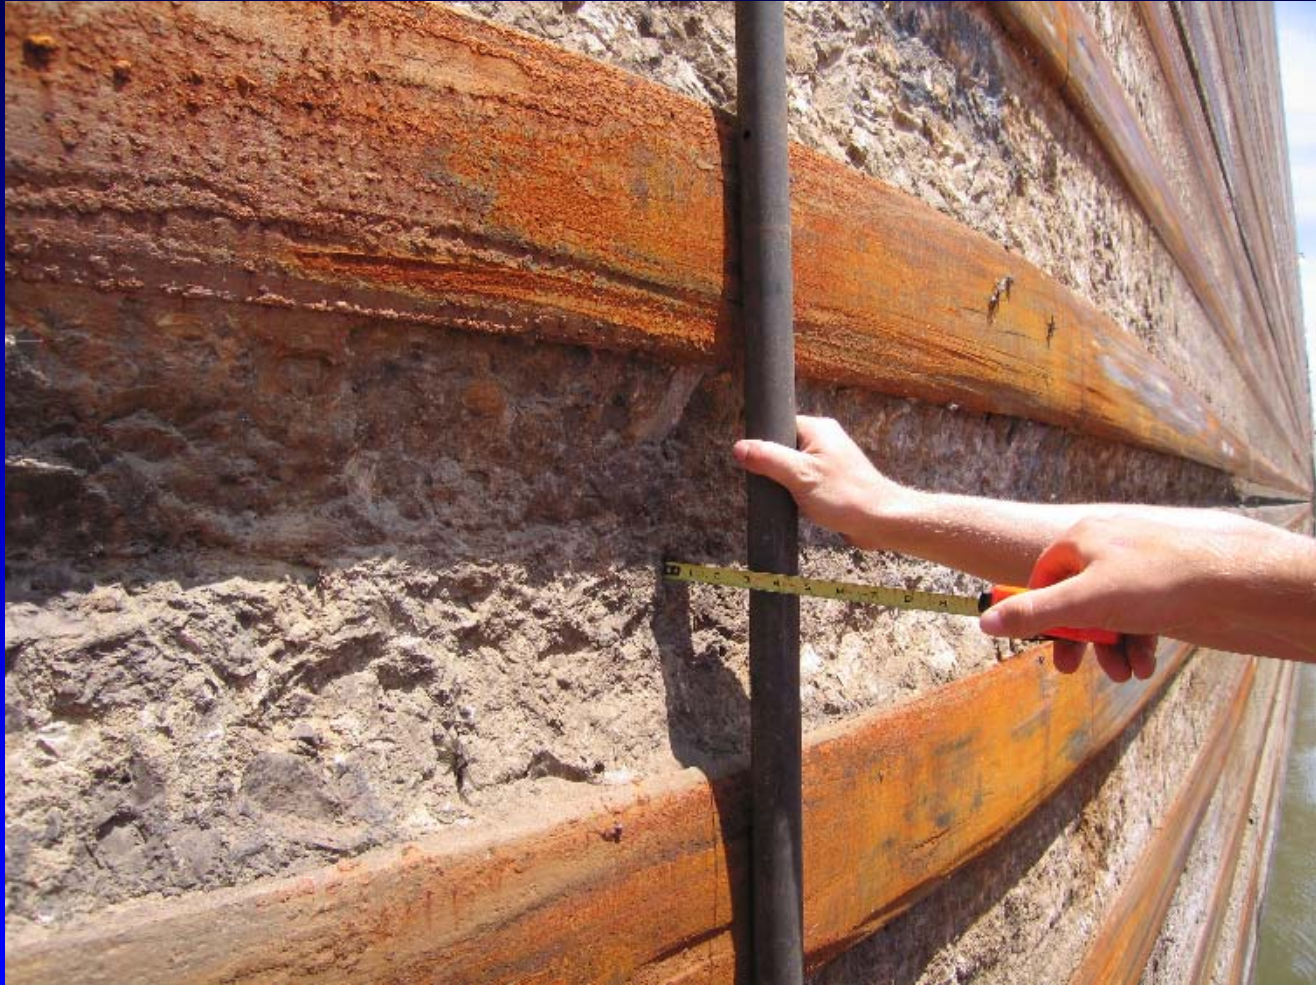
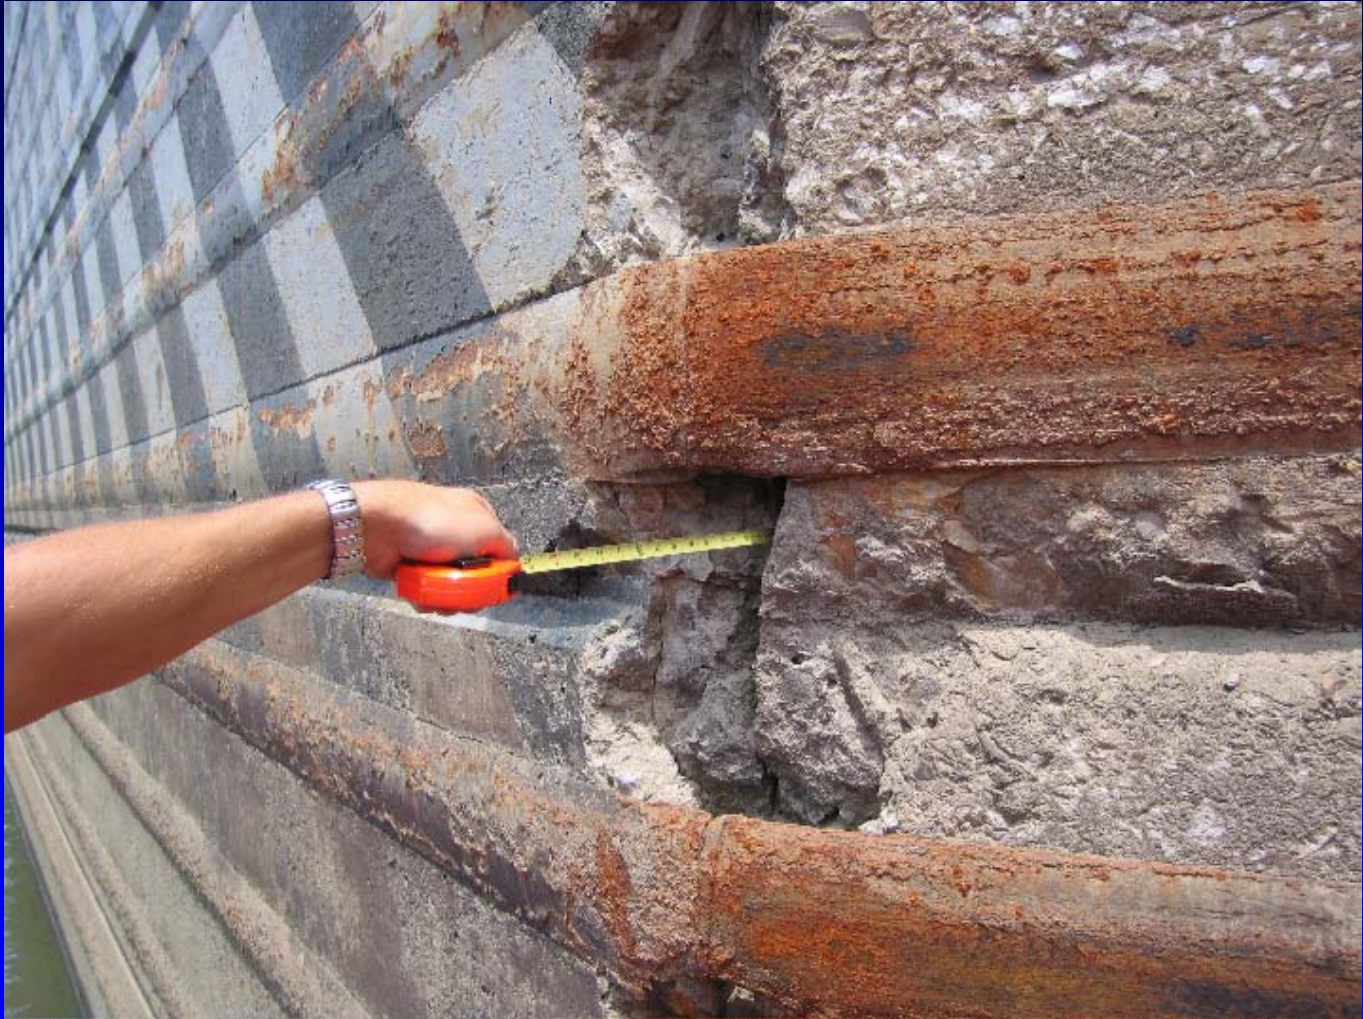
Wall Armor System Deterioration

Lock wall armor systems are experiencing large amount of damage due to large number of vessels passing through the locks. Majority of damage includes gouges and spalls in the concrete adjacent to armor strips. Many of the gouges are next to vertical joints. Several locations includes broken armor.

Majority of damage occurs in 1,200-ft lock, due to impact and abrasion by commercial barge traffic that typically use this lock. Broken wall armor is vulnerable to “catching” protruding metal on barges (a special concern for barges that have protection themselves). When armor is worn flat, it is no longer effecting in protecting the surrounding concrete.

The design parameters for this lock were insufficient, resulting in extensive wear of the lock walls. Design did not provide for wall armor protection at the concrete joints, with considerable damage to the concrete and armor. Performance prediction technology was not fully utilized.

Continuous monitoring should be undertaken to provide prediction indicators of the rate and extent of projected deterioration of the wall armor system. This will provide an indication of the amount of time available for development of non-disruptive repair methodology.
